Manhole Inspection Summary

Manhole # S49M__037MH

Insp Date: **2/11/09 11:57 AM**

Location Address: **823 S MILTON-ROSE-ALLEY**

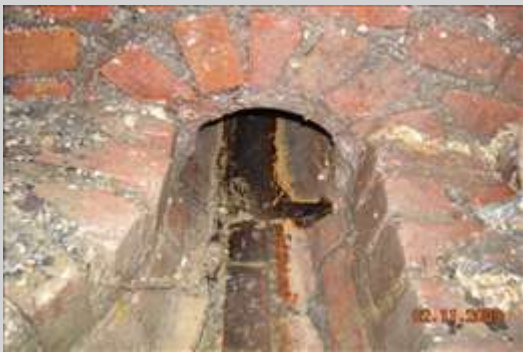
12 O'Clock Outflow

8 in. Circular Gravity Sewer
Pipe Out @ 12 O'Clock

Pipe Height: **8.4** (in.) Rod and Bar (Angled)
Pipe Material: **Clay** ☐ Pipe Lined
Invert Depth: **10.76** (ft.) Flow Characteristics: **Slow**
Deposits: ☒ None ☐ Mud ☐ Sludge ☐ Debris ☐ Grease
Silt Depth: **0** (in.) Deposits Extent:
Infiltration: **None** Pipe Seal Cond: **Sound**

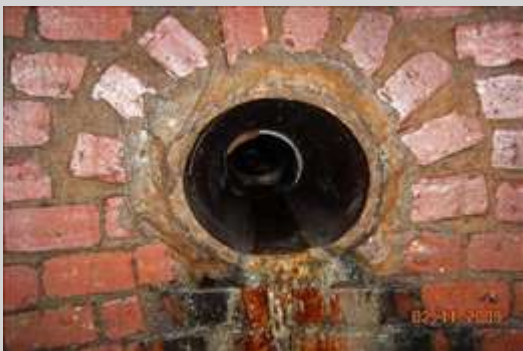
6 O'Clock Inflow

8 in. Circular Gravity Sewer
Pipe In @ 6 O'Clock

Pipe Height: **8.4** (in.) Rod and Bar (Angled)
Pipe Material: **Clay** ☐ Pipe Lined
Invert Depth: **6.41** (ft.) Flow Characteristics: **Slow**
Deposits: ☒ None ☐ Mud ☐ Sludge ☐ Debris ☐ Grease
Silt Depth: **0** (in.) Deposits Extent:
Infiltration: **None** Pipe Seal Cond: **Sound**

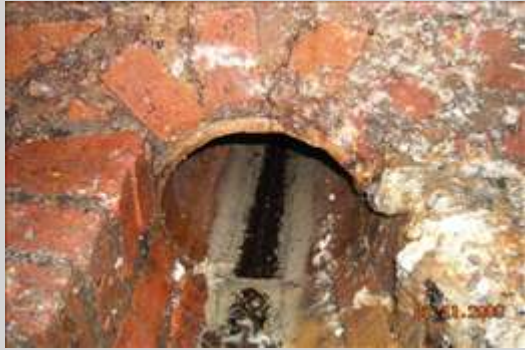
9 O'Clock Inflow

8 in. Circular Gravity Sewer
Pipe In @ 9 O'Clock

Pipe Height: **8.4** (in.) Rod and Bar (Angled)

Infiltration: **None** Pipe Seal Cond: **Sound**
